Manhole Inspection Summary

Manhole # S3700_029MH

Insp Date: **1/26/07 11:17 AM**

Location Address: **2212 23RD-22_1**

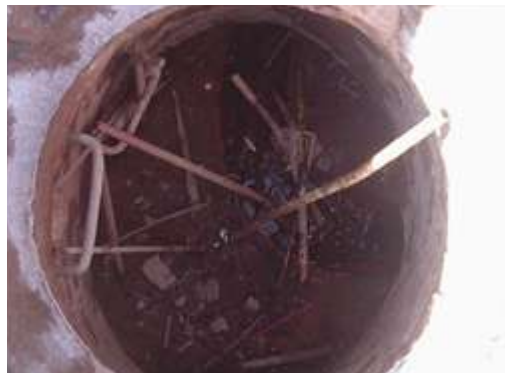
Top View

Adjustment and Barrel infiltration.
Evidence of surcharge - Bench debris.
Channel debris.

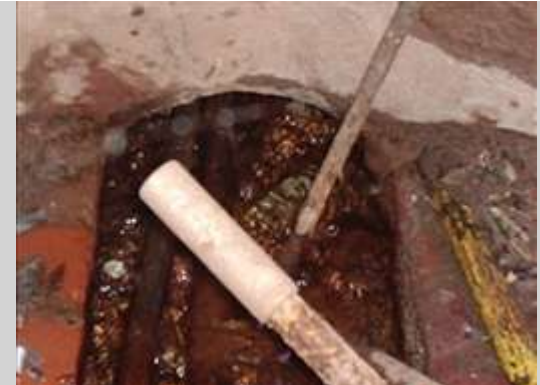
8 in. Circular Gravity Sewer Pipe Out @ 12 O'Clock

Deposits: ☐ None ☐ **Mud** ☐ Sludge ☒ **Debris** ☐ Grease

Silt Depth: **6** (in.) Deposits Extent: **Heavy**

Infiltration: **Evidence** Pipe Seal Cond: **Unknown**

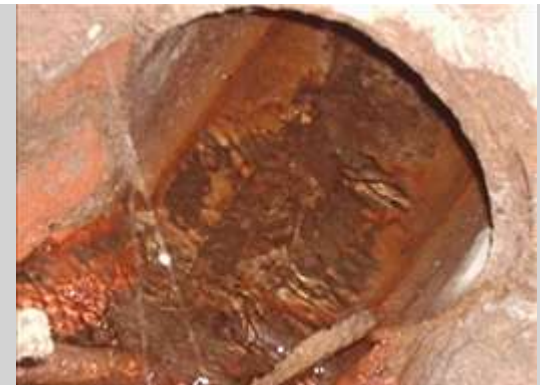
8 in. Circular Gravity Sewer Pipe In @ 3 O'Clock

Deposits: ☐ None ☒ **Mud** ☐ Sludge ☐ Debris ☐ Grease

Silt Depth: **0** (in.) Deposits Extent: **Light**

Infiltration: **Evidence** Pipe Seal Cond: **Unknown**
